# RESEARCH MEMORANDUM

FLIGHT EXPERIENCE WITH TWO HIGH-SPEED AIRPLANES  
HAVING VIOLENT LATERAL-LONGITUDINAL  
COUPLING IN AILERON ROLLS

By NACA High-Speed Flight Station

NACA RM H55A13

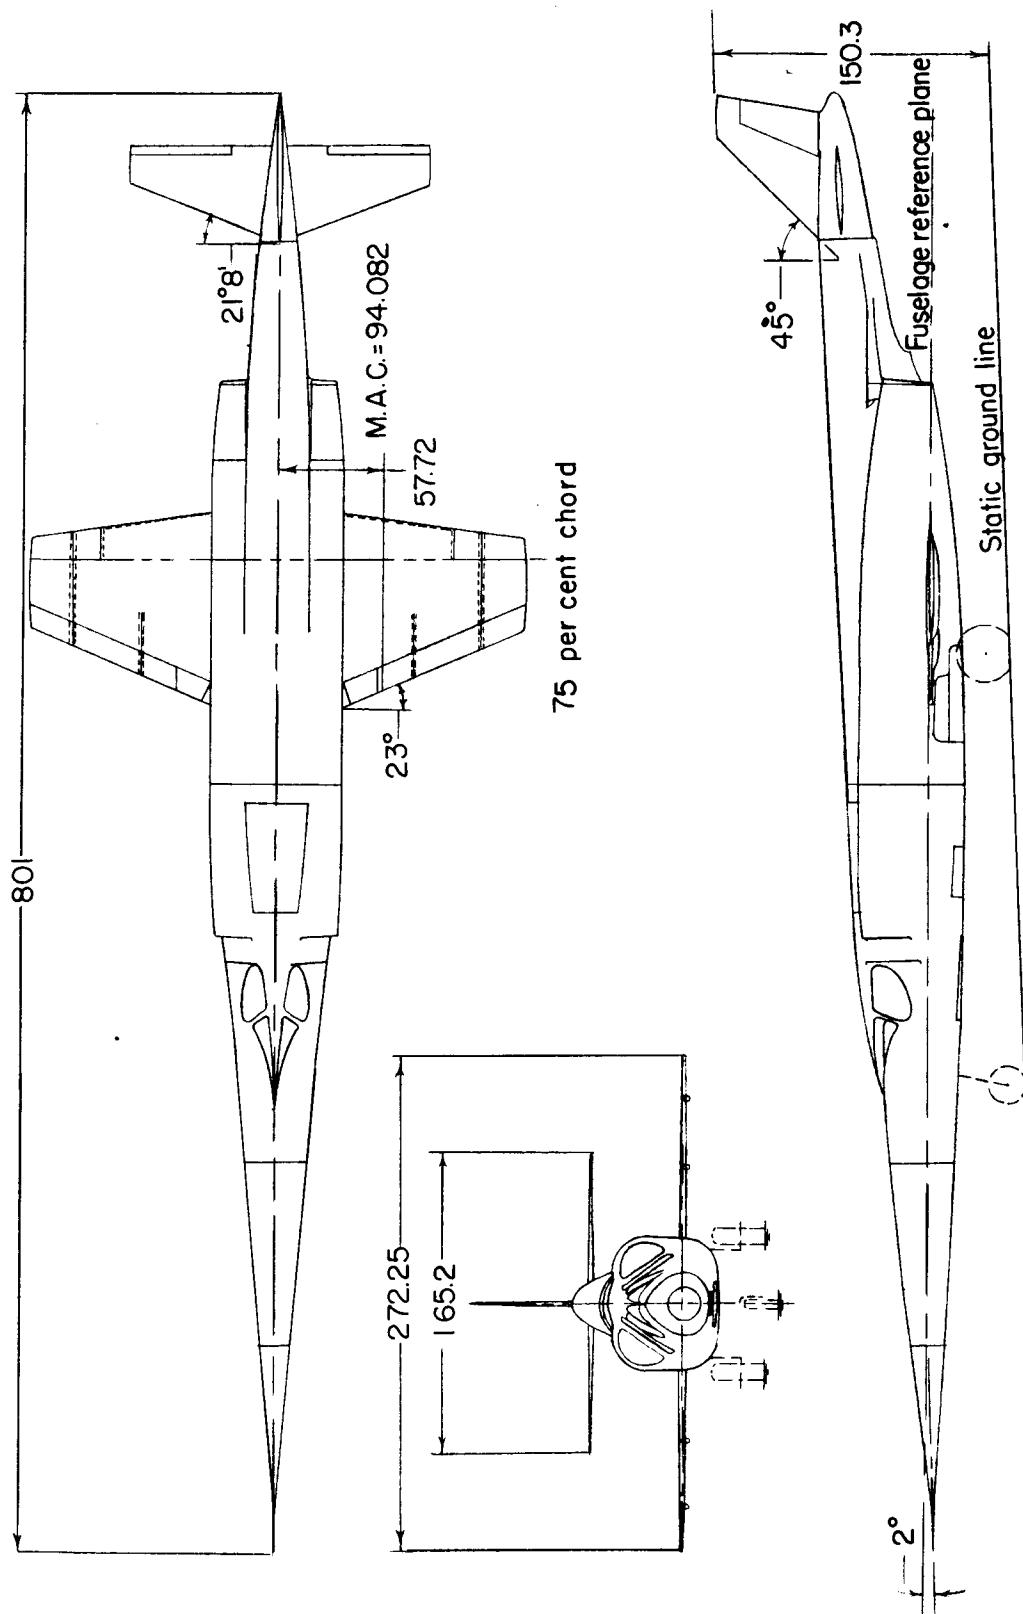
Figure 1.- A three-view drawing of airplane A. All dimensions in inches.

The mass and geometric characteristics of airplane A, the X-3 research airplane, are presented in table I, a three-view drawing is shown as figure 1, and photographs are shown as figure 2.

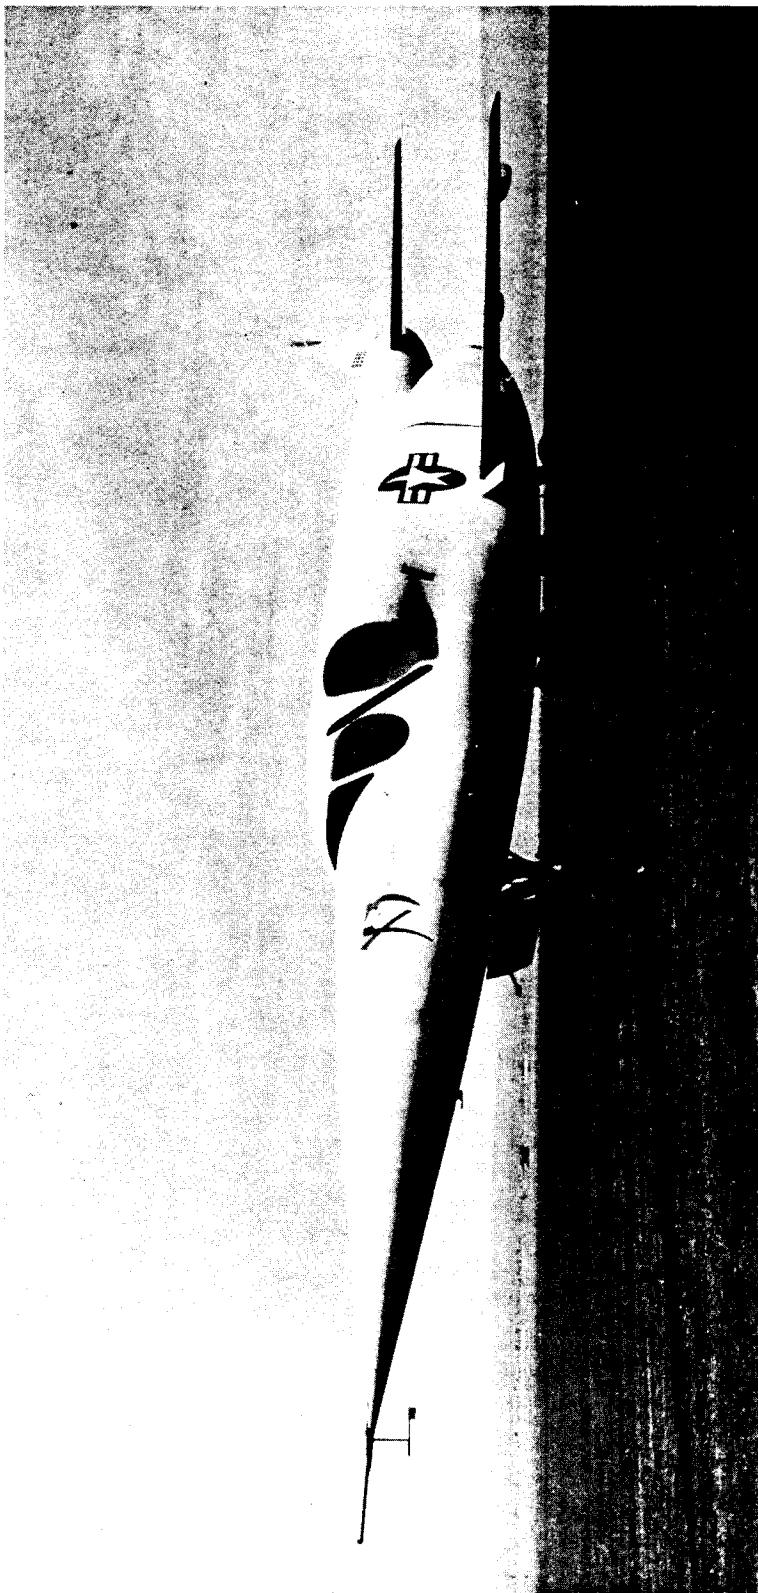
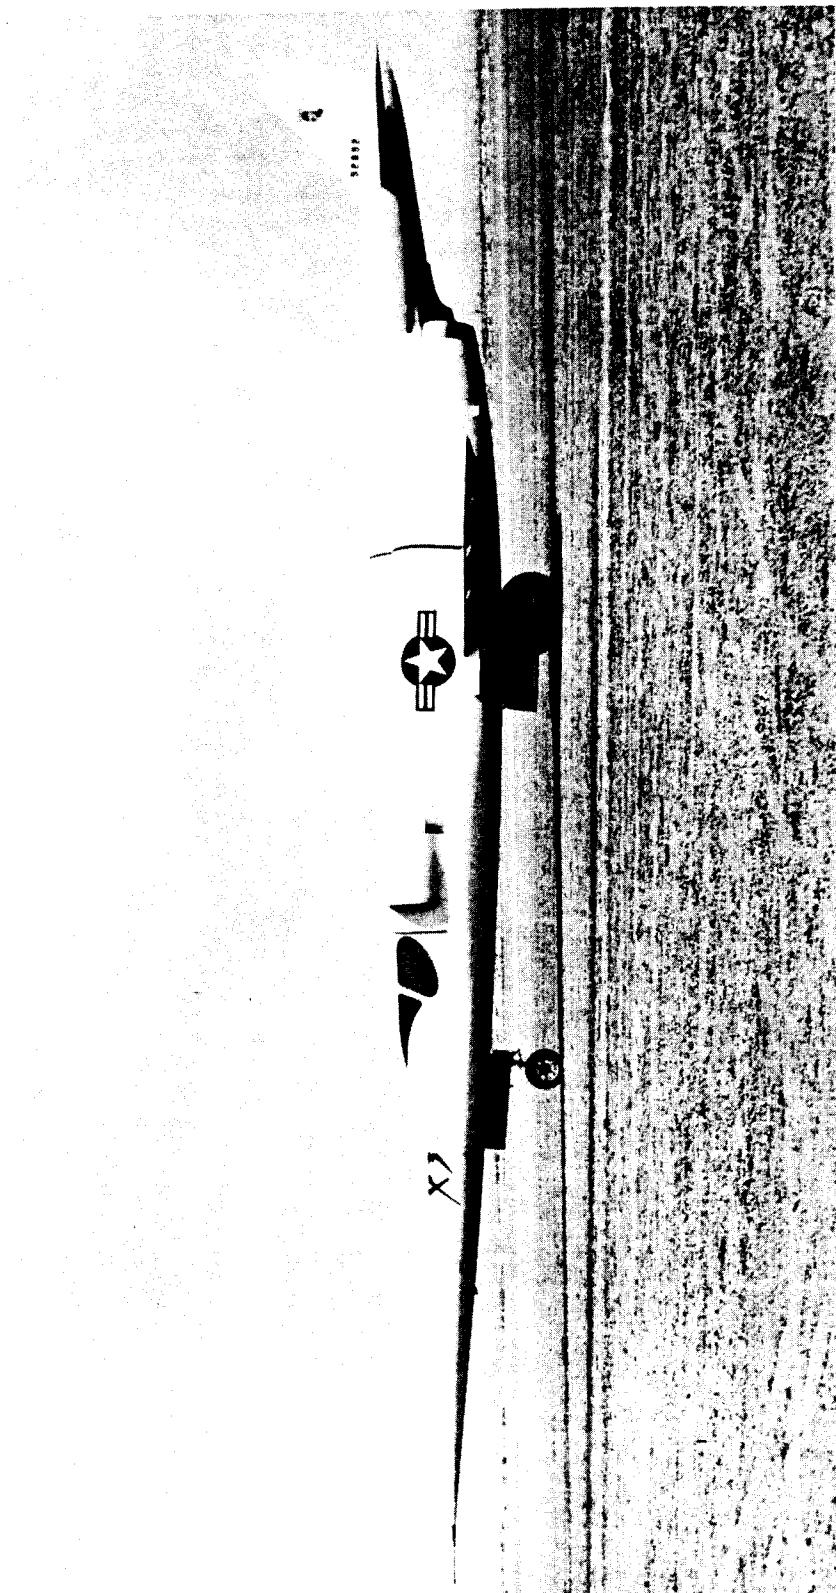
(a) Three-quarter front view.

Figure 2.- Photographs of airplane A.

(b) Side view.

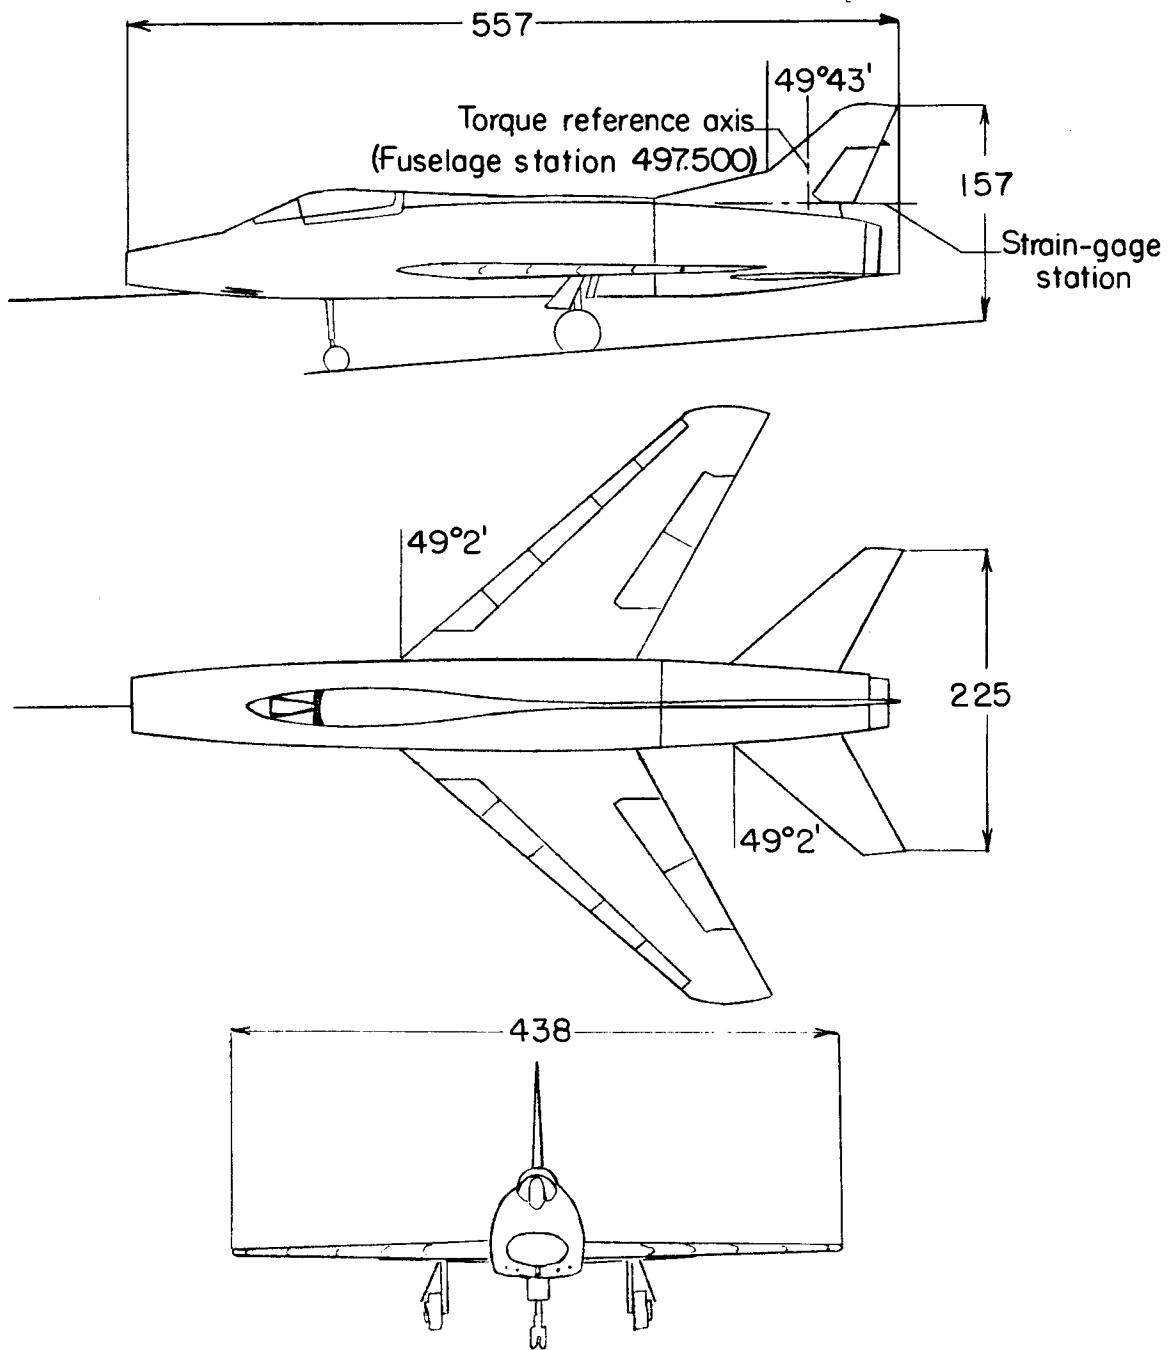
Figure 3.- Three-view drawing of airplane B. All dimensions in inches.

Airplane B is a fighter type, the mass and geometric characteristics of which are presented in table II. A three-view drawing is shown as figure 3 and photographs as figure 4.

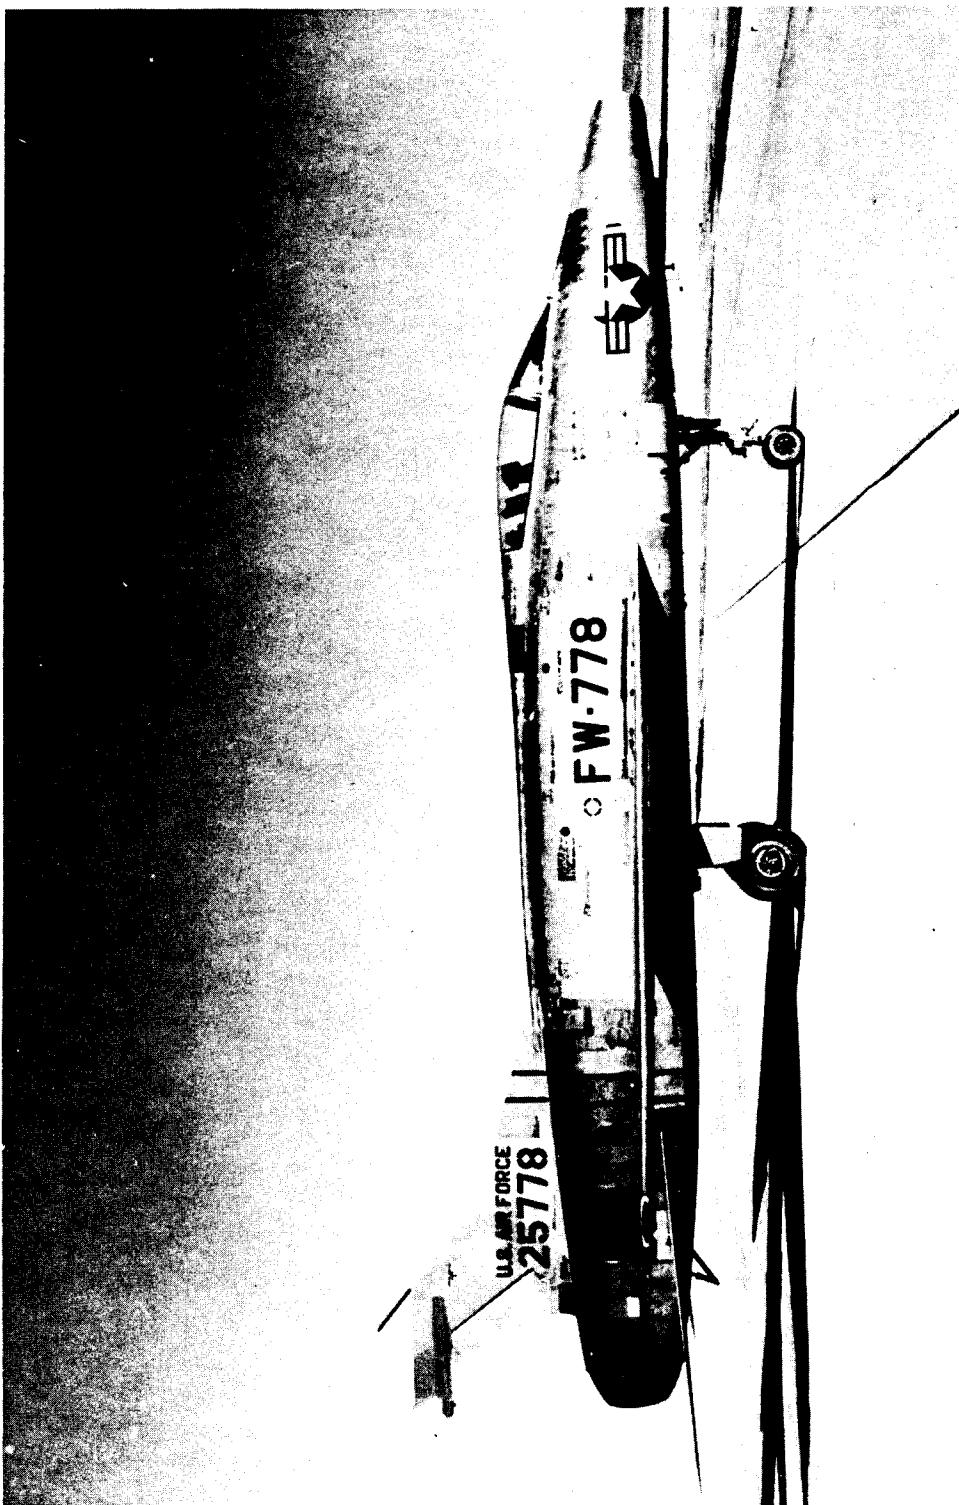
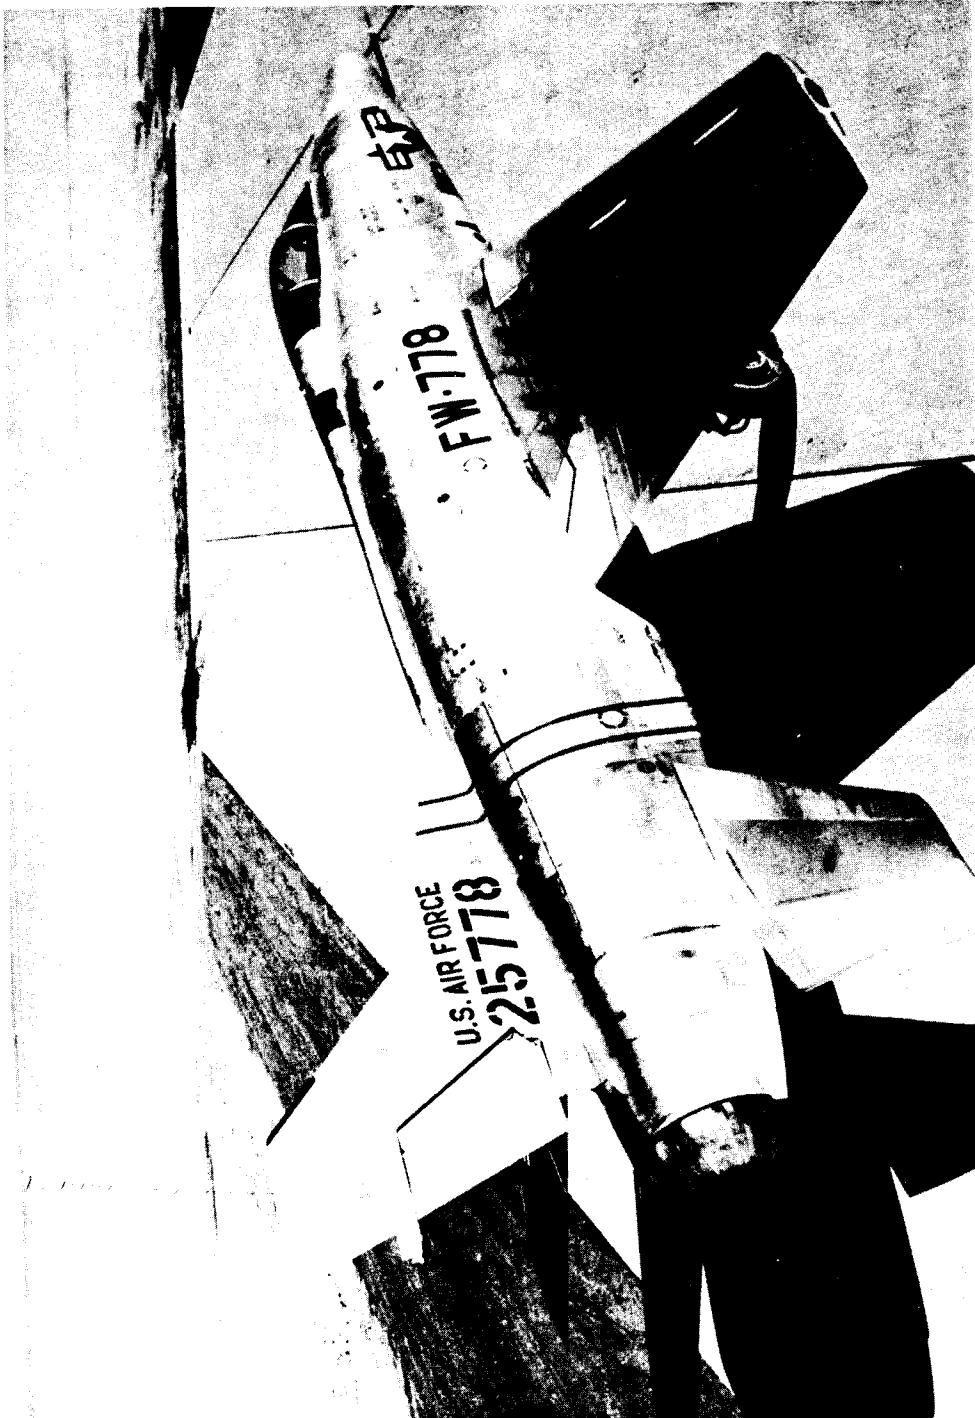
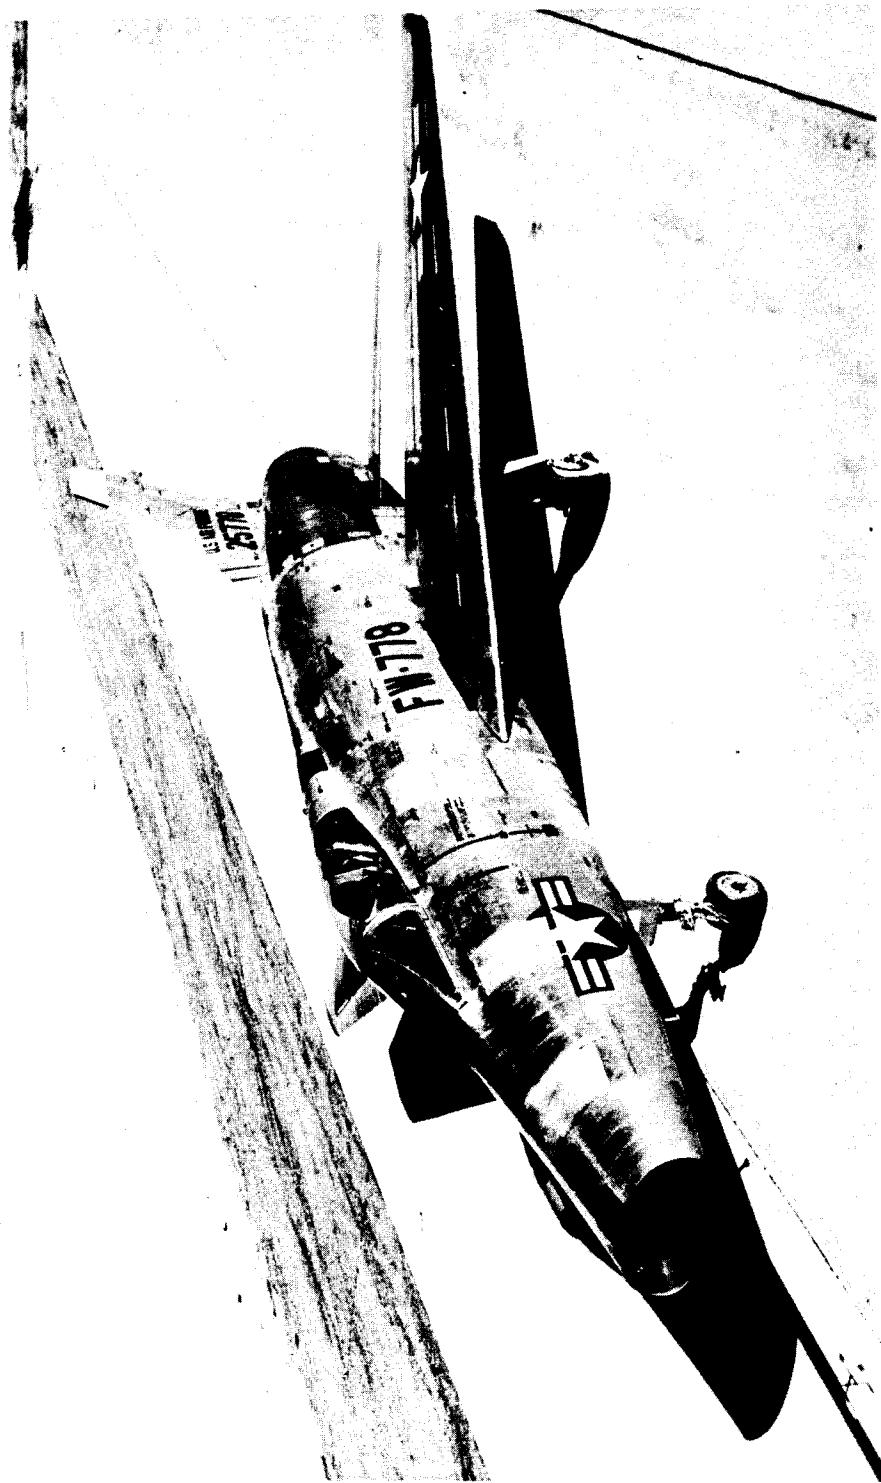
L-87522  
(a) Side view.

Figure 4.- Photographs of airplane B.

(b) Three-quarter rear view.

(c) Three-quarter front view.

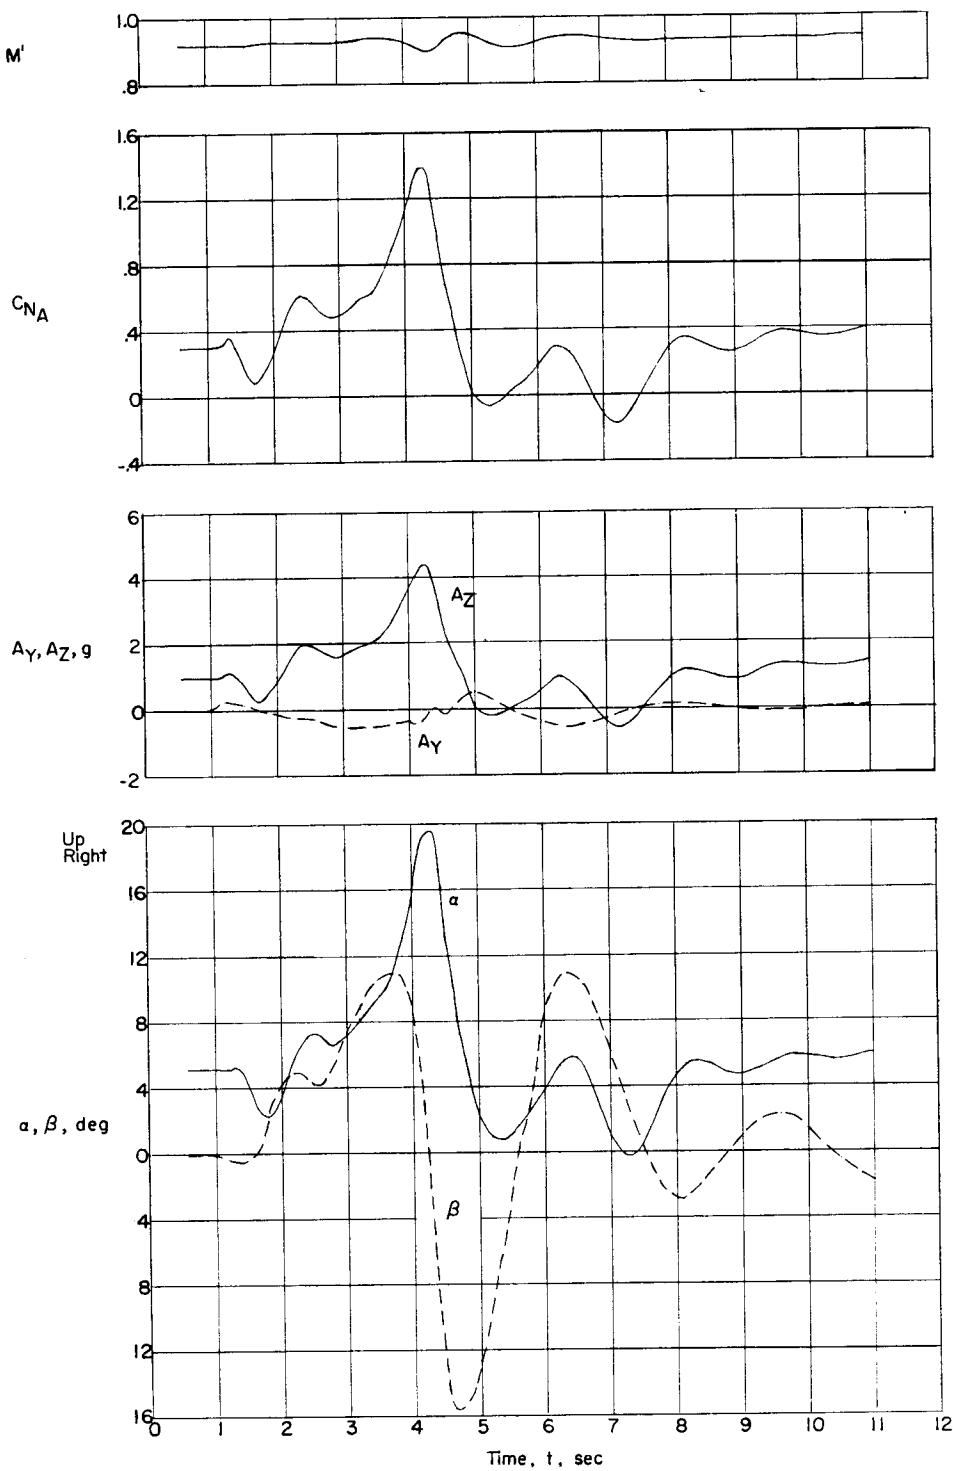
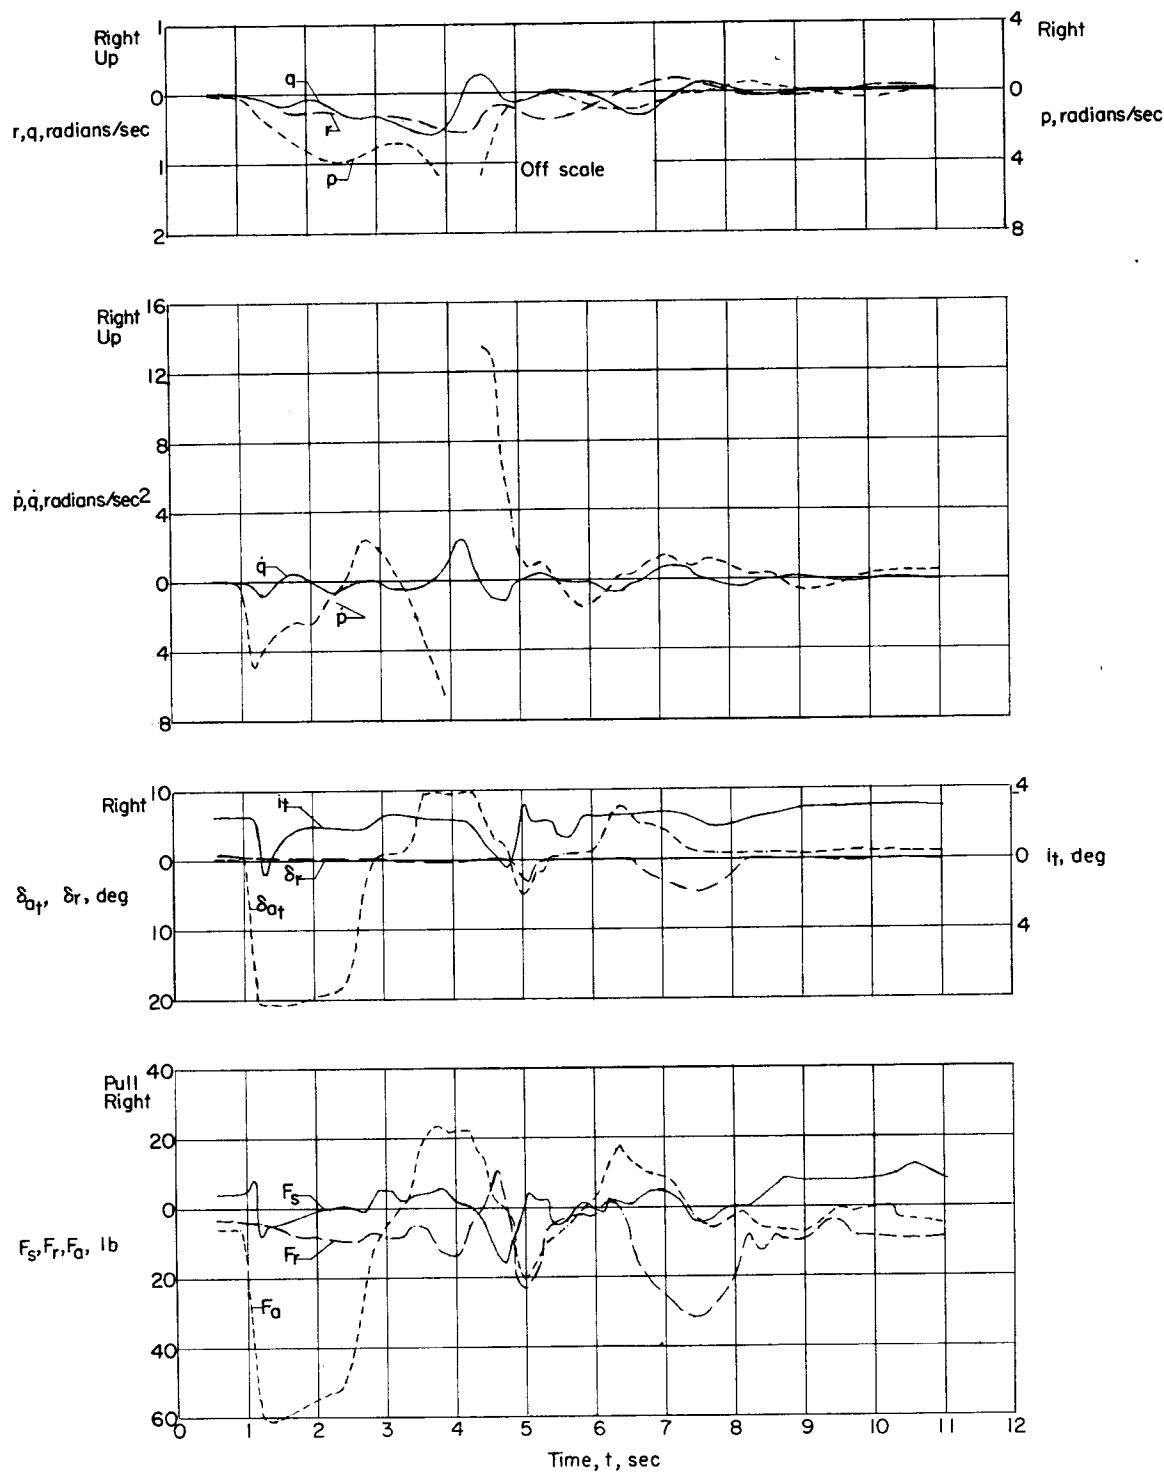
(a) Stability and control plots.

Figure 5.- Time history of quantities measured during an abrupt aileron roll with airplane A at  $M \approx 0.92$ .  $h_p \approx 30,000$  feet.

(b) Stability and control plots.

The time history of an abrupt left aileron roll for airplane A flying at a Mach number of about 0.92 at an altitude of 30,000 feet is presented as figure 5. While the ailerons are deflected for the aileron roll, a favorable sideslip angle is generated, together with a rather large increase in angle of attack. (The initial decrease in angle of attack is probably attributable to pilot stabilizer control input.) At time 3.8 seconds, even though the pilot is now applying 10° right aileron control, left rolling velocity increased and exceeded 5 radians/sec accompanied by violent pitching and sideslipping motions. During this uncontrollable phase of the maneuver, an angle of attack of 20° and left sideslip angle of 16° were encountered. It might be of interest to note that the onset of the violent maneuver coincided with the attainment of the angle of attack ( $\alpha \approx 8^\circ$ ) at which unpublished flight data indicates the occurrence of reduction of longitudinal stability. Also, the angle of attack of 8° corresponds to the angle of attack at which a reduction in the measured wing lift slope occurs; therefore, large wing loads were not experienced at the maximum angles of attack (fig. 5(c)). After the primary rolling motion has subsided at  $t = 5$  seconds, the large lateral and longitudinal motions damp fairly well.

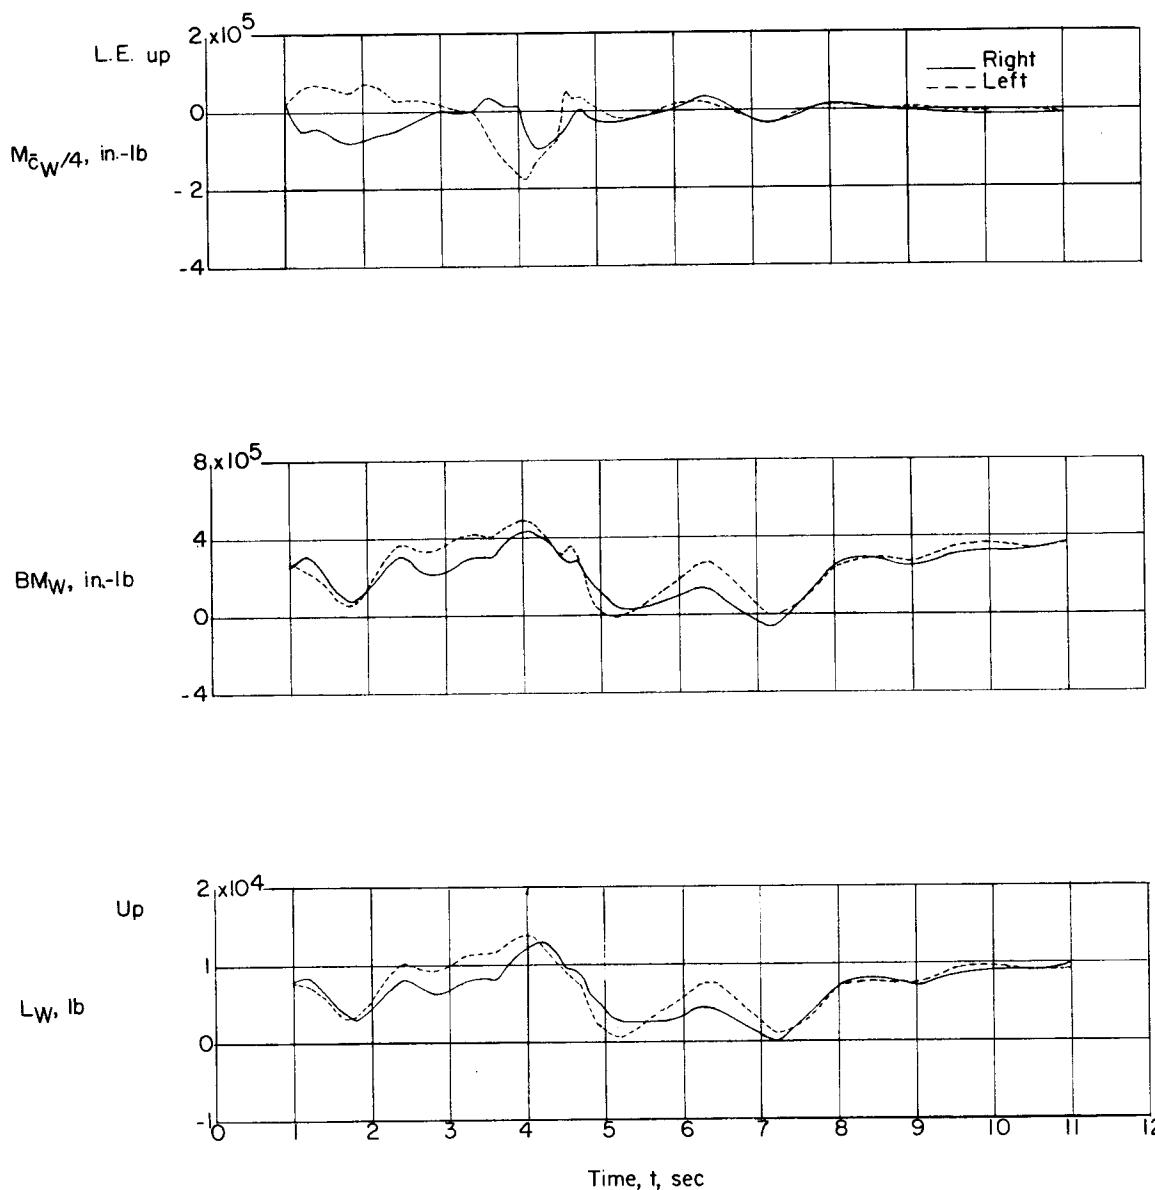
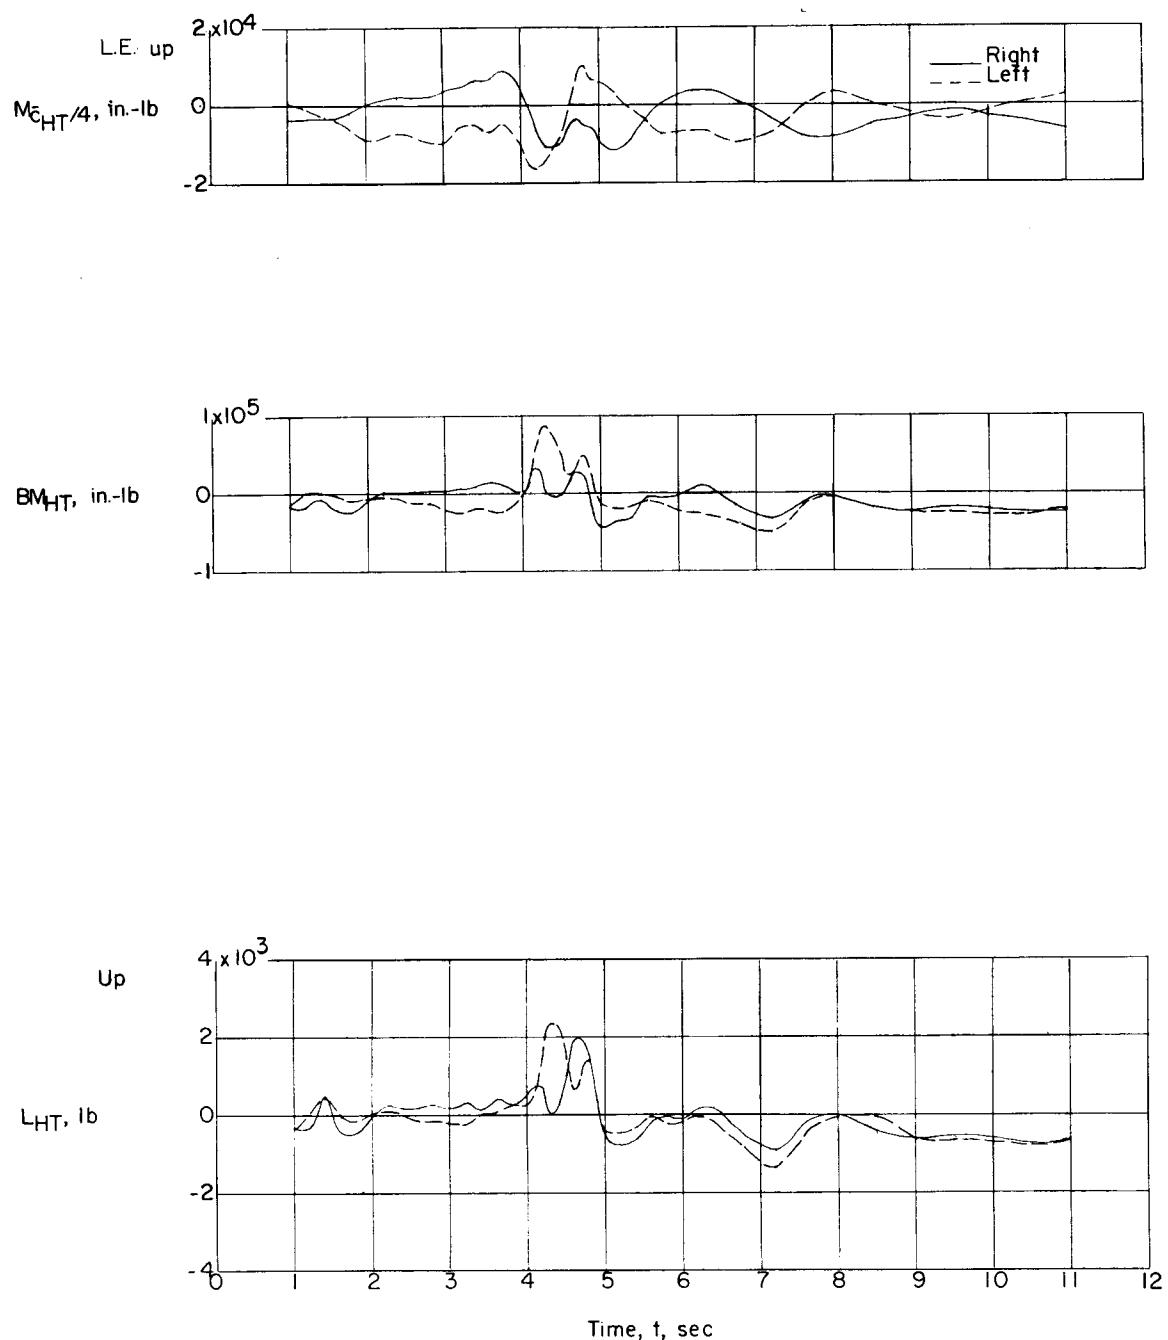
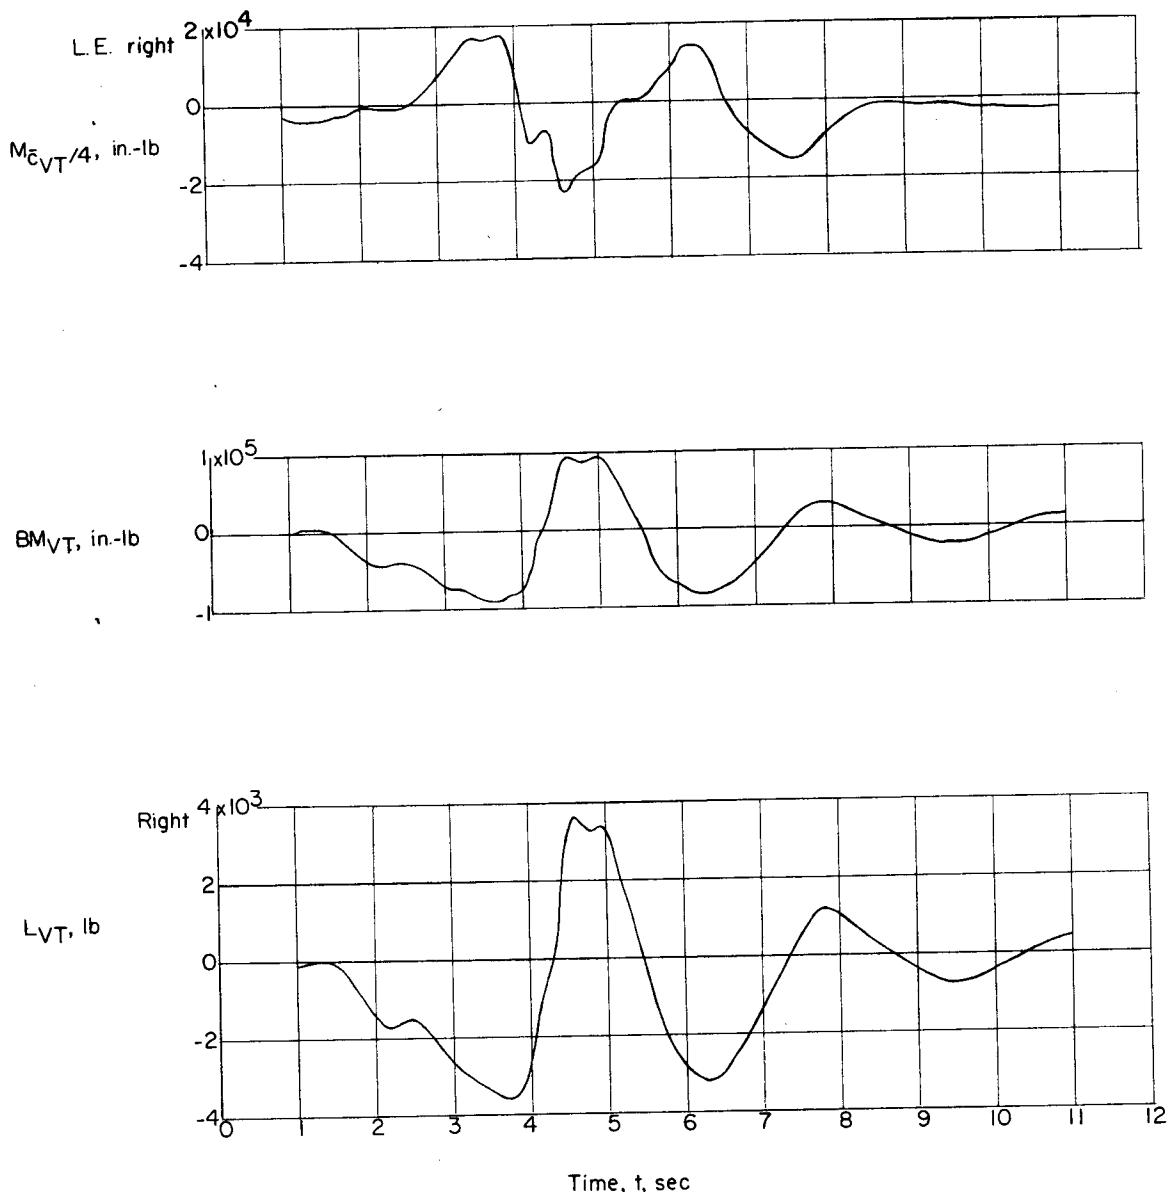
(c) Wing structural loads.

(d) Horizontal tail structural loads.

(e) Vertical tail structural loads.

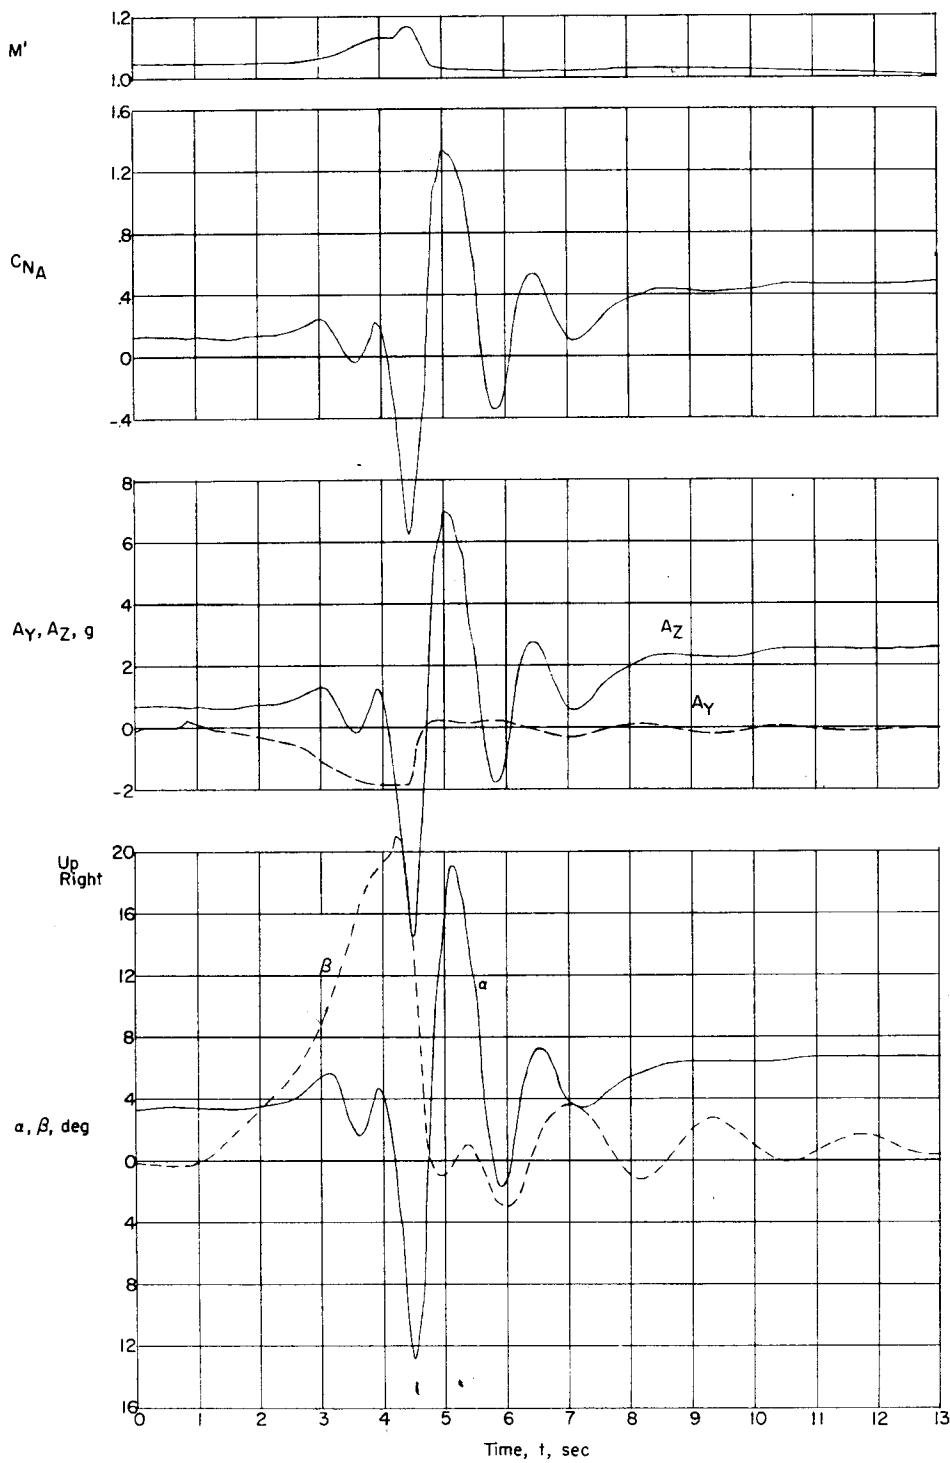
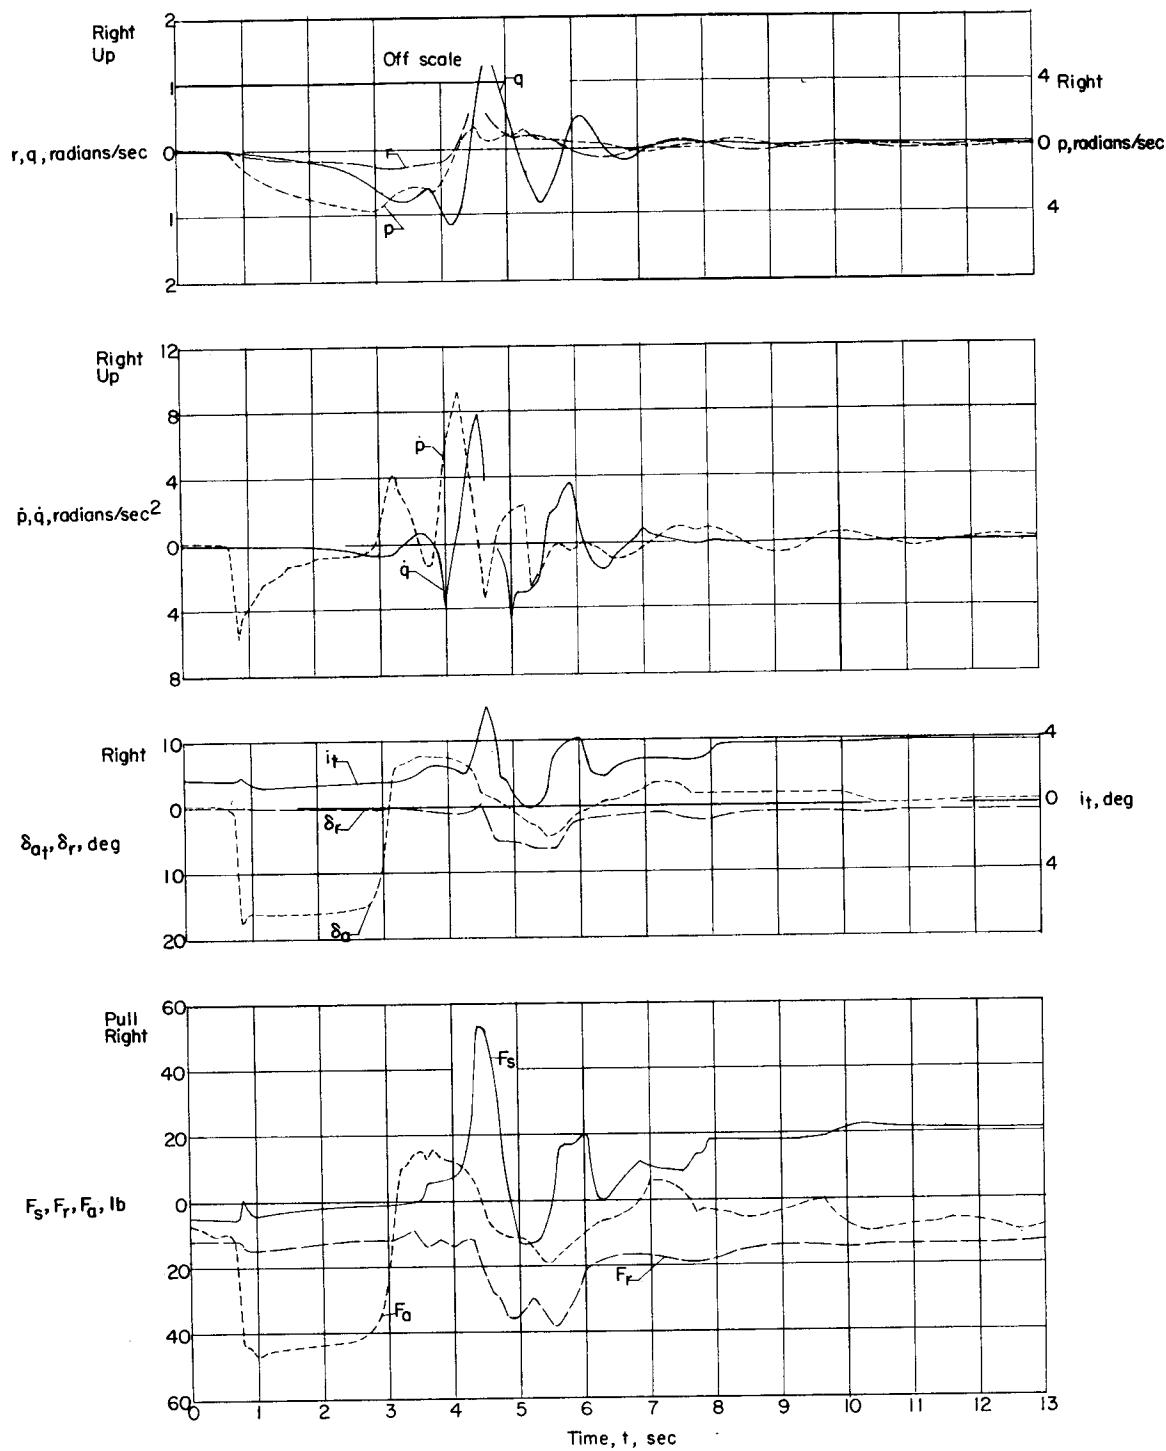
(a) Stability and control plots.

Figure 6.- Time history of quantities measured during an abrupt aileron roll with airplane A at  $M = 1.05$ .  $h_p \approx 30,000$  feet.

(b) Stability and control plots.

Another left roll time history for airplane A is presented in figure 6 for a Mach number of about 1.05. During this maneuver the favorable sideslip builds up rapidly with roll velocity and peaks at 21° at the time the airplane ceases rolling left. This large sideslip angle results in about 2g transverse acceleration. Near the time at which maximum sideslip occurs ( $t \approx 4.0$  sec) a large divergence in pitch develops in the negative direction which attains about -6.7g. The pilot applied control to stop this pitch-down and immediately reduced the control deflection, but was unable to avoid obtaining 7g when the airplane pitched up. Maximum wing loads measured during the maneuver did not approach or exceed the design limit load (fig. 6(c)); however, the fuselage load obtained from airplane weight and acceleration, and horizontal tail loads, and wing load showed maximum values of 63,000 pounds. These maximum values approximated the limit design total load of the fuselage. The measured horizontal tail loads were near limit design load (fig. 6(d)). The maximum measured vertical tail loads reached approximately 50 percent of the limit load (fig. 6(e)) at sideslip angles of 21°. It may be noted that a reduction in vertical tail load with sideslip was experienced at sideslip angles about 8°. In this maneuver, as in figure 5, when the rolling stopped, the airplane motions quickly damped.
